# DIRECT PETROL INJECTION AND THE HIGH-PRESSURE FUEL PUMP

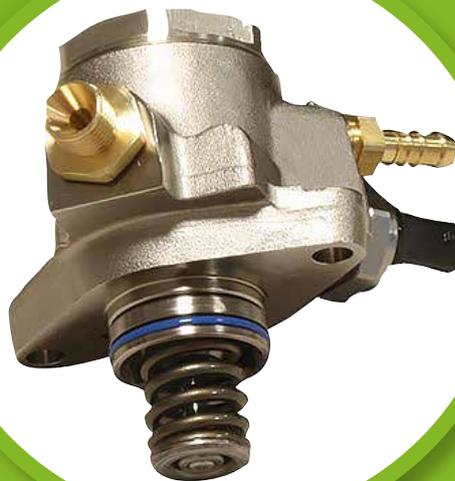
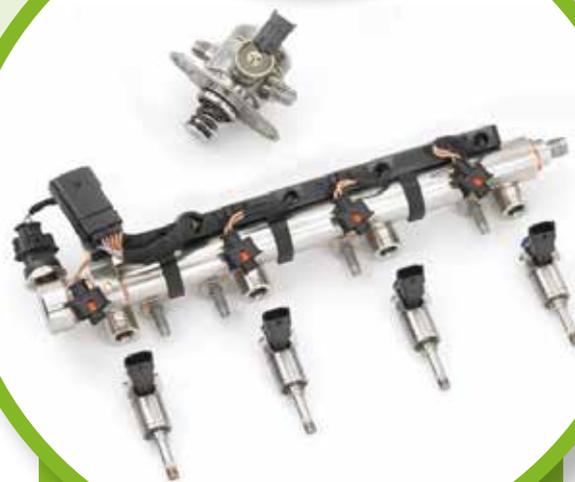
Essentially, the direct-injection system (pic 2) injects a precise amount of fuel directly into the combustion chamber at much higher pressures than a traditional petrol-injection system, allowing the engine to run leaner and more efficiently.
